Daily Update

April 24

Devil's Slide (post mile 39.14)

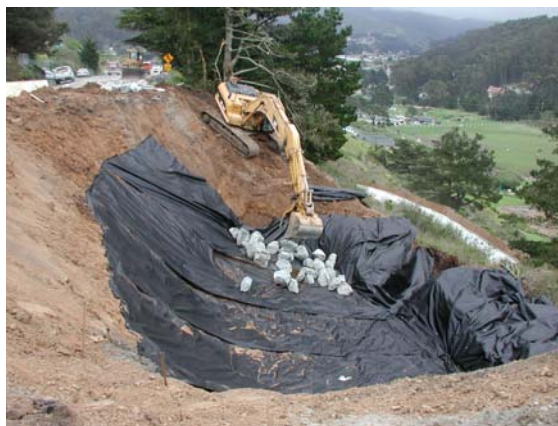
- Repair work continued with the installation of drains and placement of rocks at the bottom of the excavated portion of the hillside.
